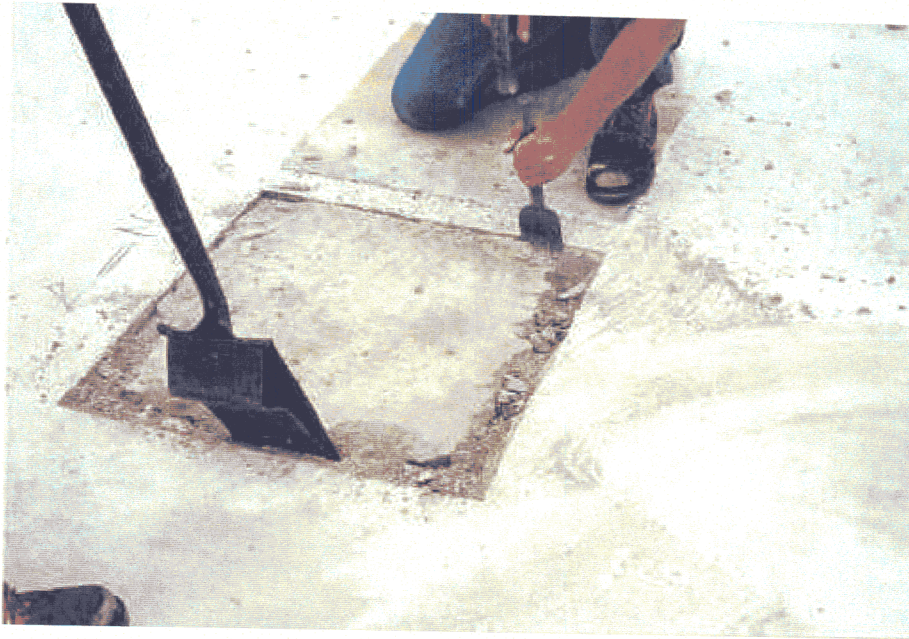
Figure 2.6-23 Inspection Opening No. 4

- e. Asphalt mopping layer.
- f. Approximately 1/2-inch thick layer (tapered) All-Weather Crete asphalt/perlite fill (wet).
- g. Approximately 1-1/2-inch thick layer of composite bitumen-aggregate fill (wet).
- h. Approximately 1/8-inch thick layer of asphalt.
- i. Concrete roof slab.
